Fourth Five-Year Review Report

FMC Corporation Yakima

Superfund Site

SEPTEMBER 2013

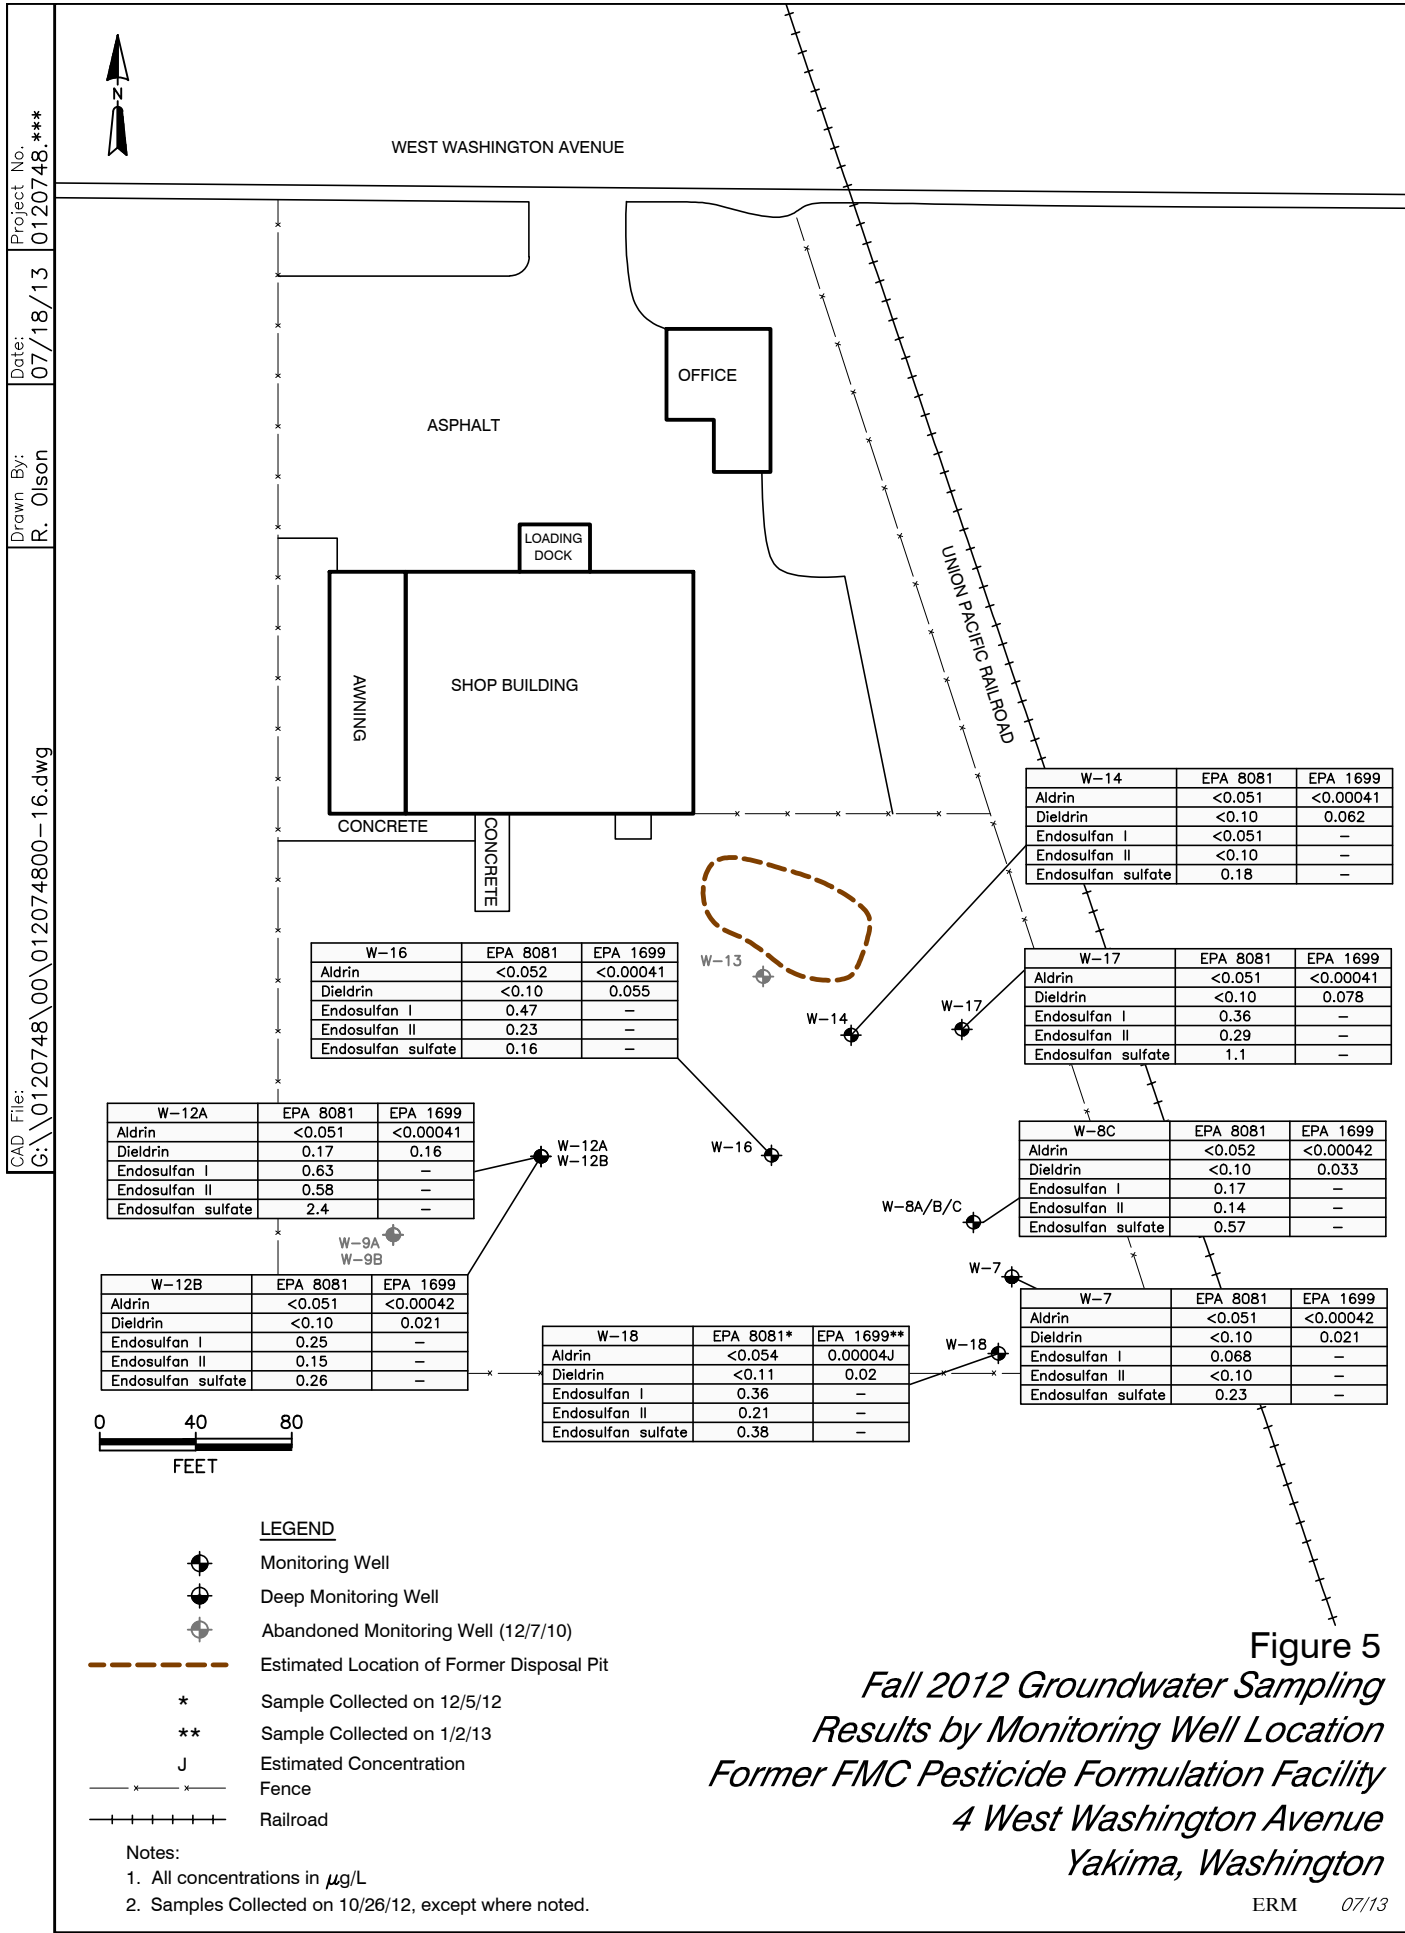
Figure 5
Fall 2012 Groundwater Sampling
Results by Monitoring Well Location
Former FMC Pesticide Formulation Facility
4 West Washington Avenue
Yakima, Washington

The screened cobble backfill is much more permeable since the fines (silt and sand) were removed. As a result, groundwater flows through this area more easily than before the excavation and at a faster rate than the surrounding areas, especially when the groundwater levels are elevated during the summer and fall irrigation season. Since the cobbles are more permeable than the surrounding soils, groundwater elevations are slightly lower within this area immediately adjacent to and above soil with residual organochlorine compound contamination. Excess groundwater is pulled through those residually contaminated soils into the cobble backfill and drawn in a cross-gradient direction toward the former disposal pit area. As a result, maximum concentrations of organochlorine compounds are typically detected in monitoring wells immediately down gradient after the seasonal high water table occurs. Figures 3 and 4 in the Appendix show the groundwater table elevations across the site for the fall 2012 and spring 2013 sampling campaigns (respectively). Figures 5 and 6 in the Appendix show the 2012 and 2013 contaminant concentrations (respectively) by well.

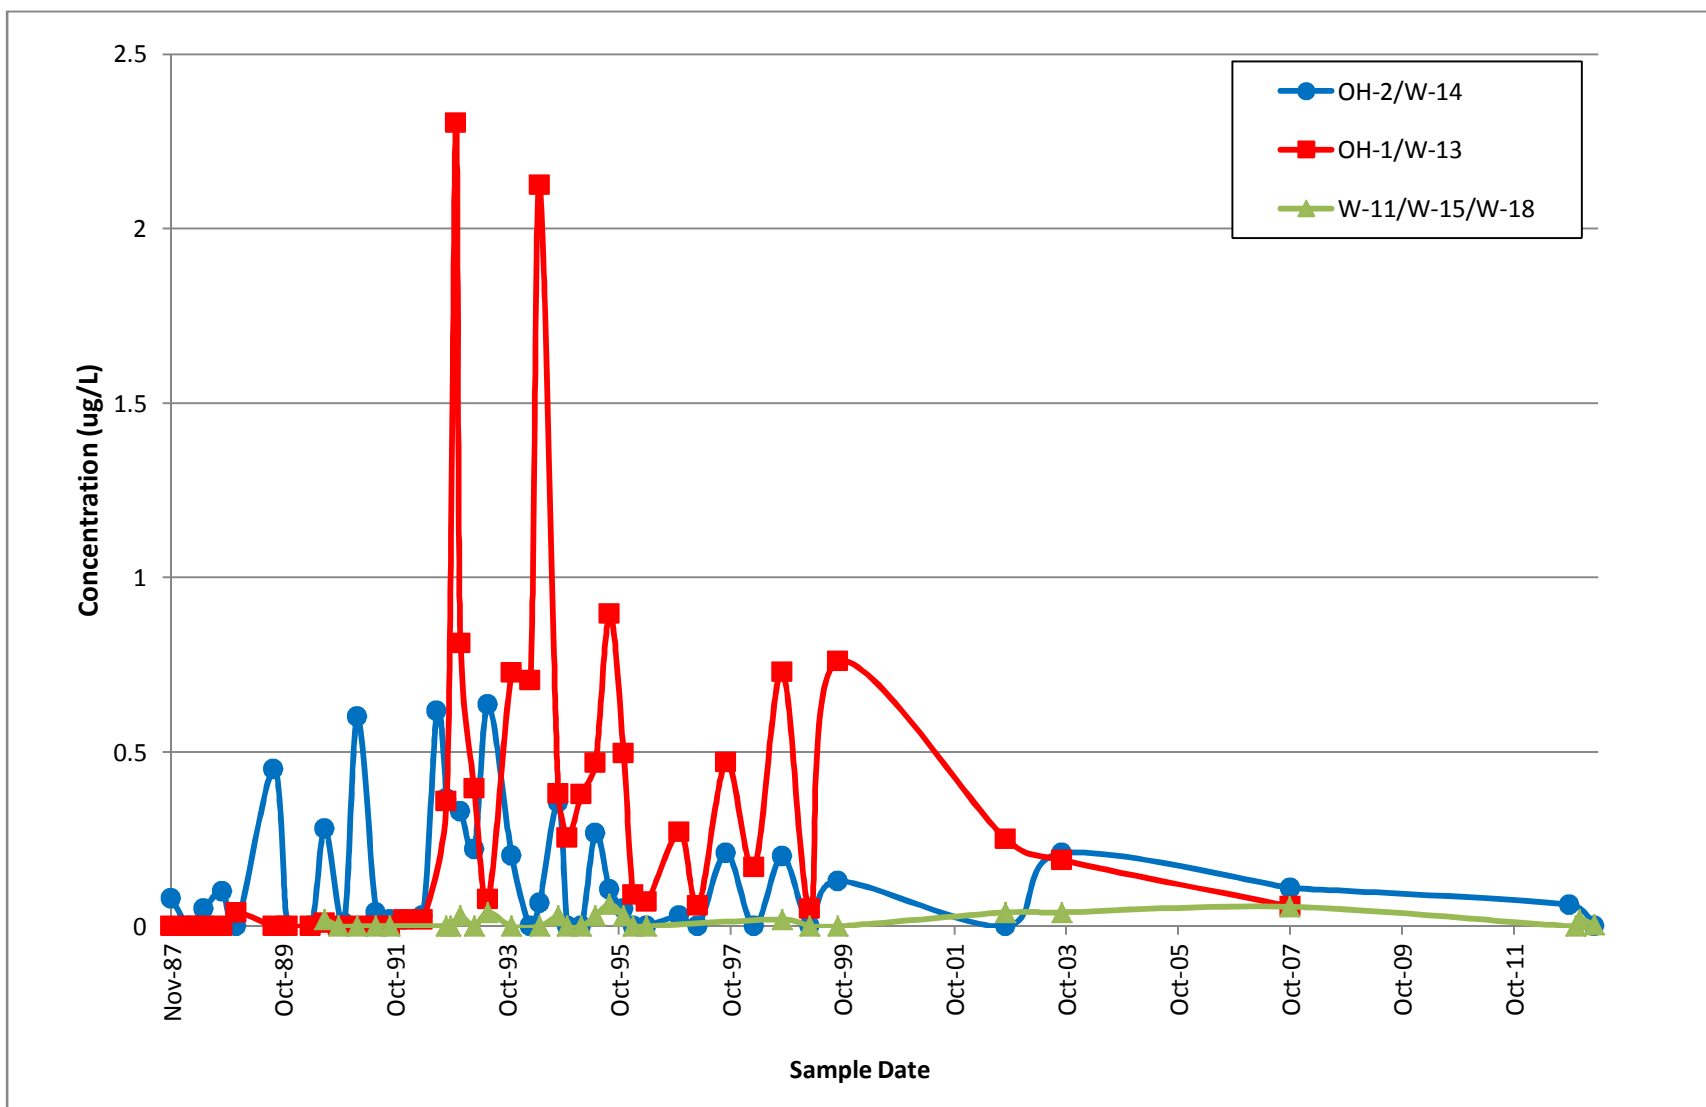
Figure 7
Long-term Trend of Dieldrin Plus Aldrin in Groundwater
Former FMC Pesticide Formulation Facility
Yakima, Washington

The long-term trends for aldrin plus dieldrin and for total endosulfans are provided in figures 7 and 8 in the Appendix. Generally, the trends for these contaminants have decreased over the life of the monitoring program and are at low levels compared with peak concentrations detected immediately following active remediation.

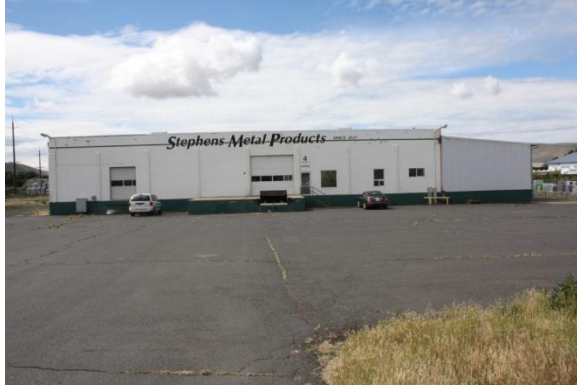
Front of Stephens Metal Products warehouse – parcel address is 4 W. Washington Avenue in Yakima, Washington (business has moved but is about to lease to another light industrial business).

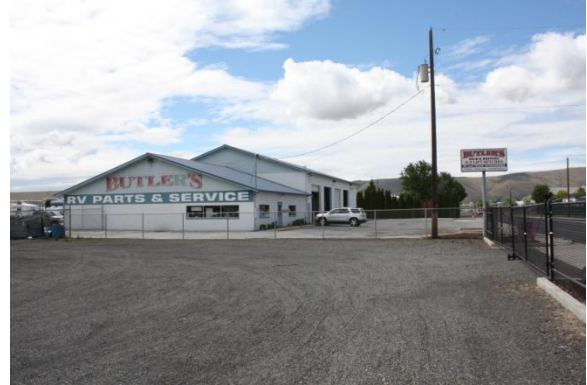
Butler's Welding and RV Accessories – parcel address is 1909 Longfibre Road in Yakima, Washington (another long time business on the former FMC facility site).

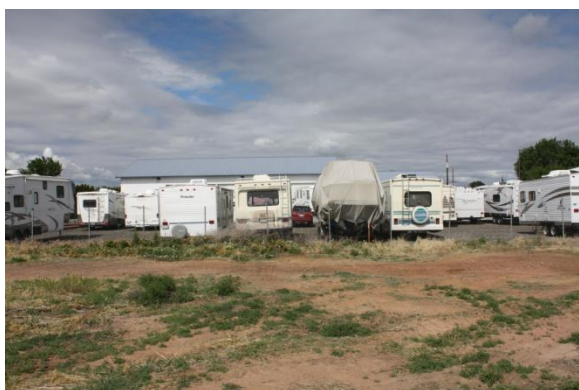
Looking west toward the back of the Butler property from the Stephens Metal Products yard.
